**CAELAR<sup>®</sup> LB**

**Superior Anti-corrosion**  
Corrosion resistance of  
Iron exceed SUS

Nihon Ruspert Co., Ltd.

# Corrosion resistance of Iron exceed SUS

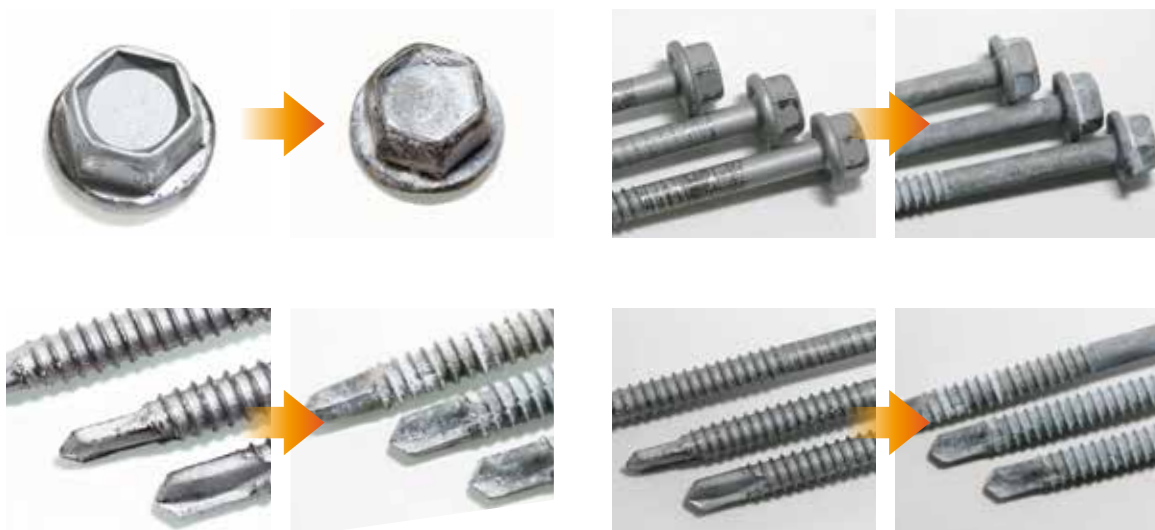
SST 2000 H

**No red rust occurred**

- The pictures in left and in right to show the condition of drilling damage before SST, and drilling screw condition after testing
- White material occurred due to the effect of anti-corrosion by self-sacrifice, but no red rust was found

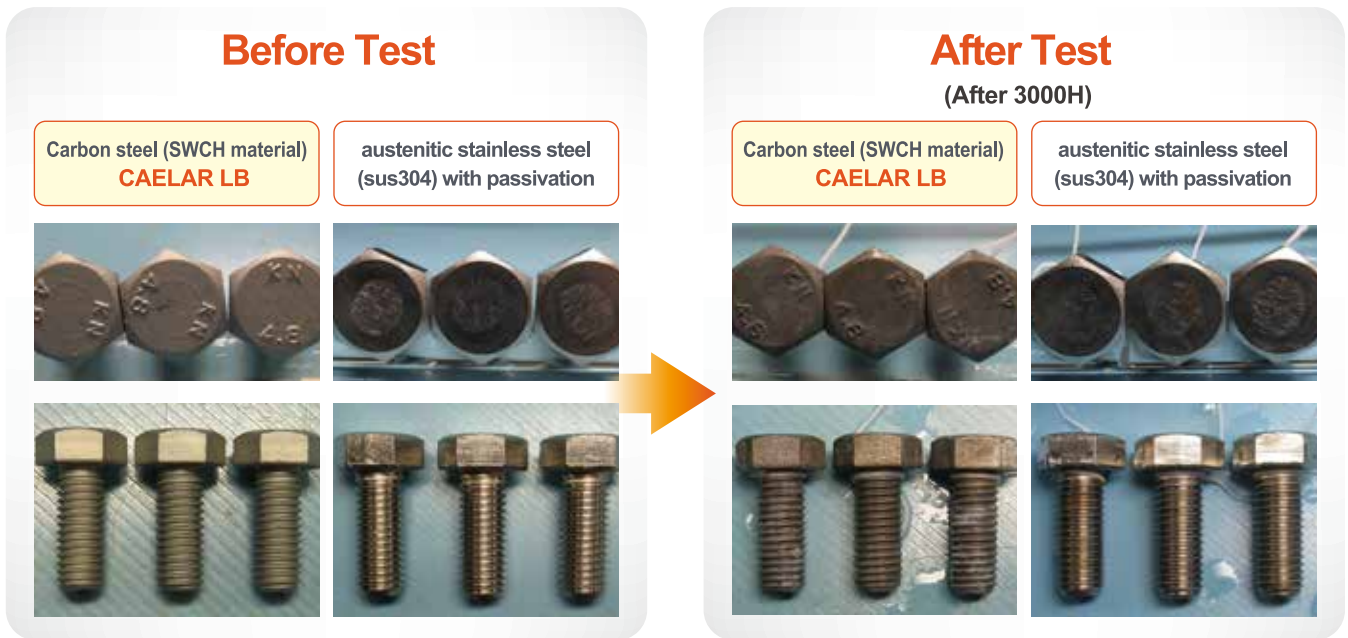
## 1. Salt spray test

JIS Z 2371 / 3000H finish

No red rust occurred

Test sample: Bolt M8 x 20  
Film thickness: 11µm

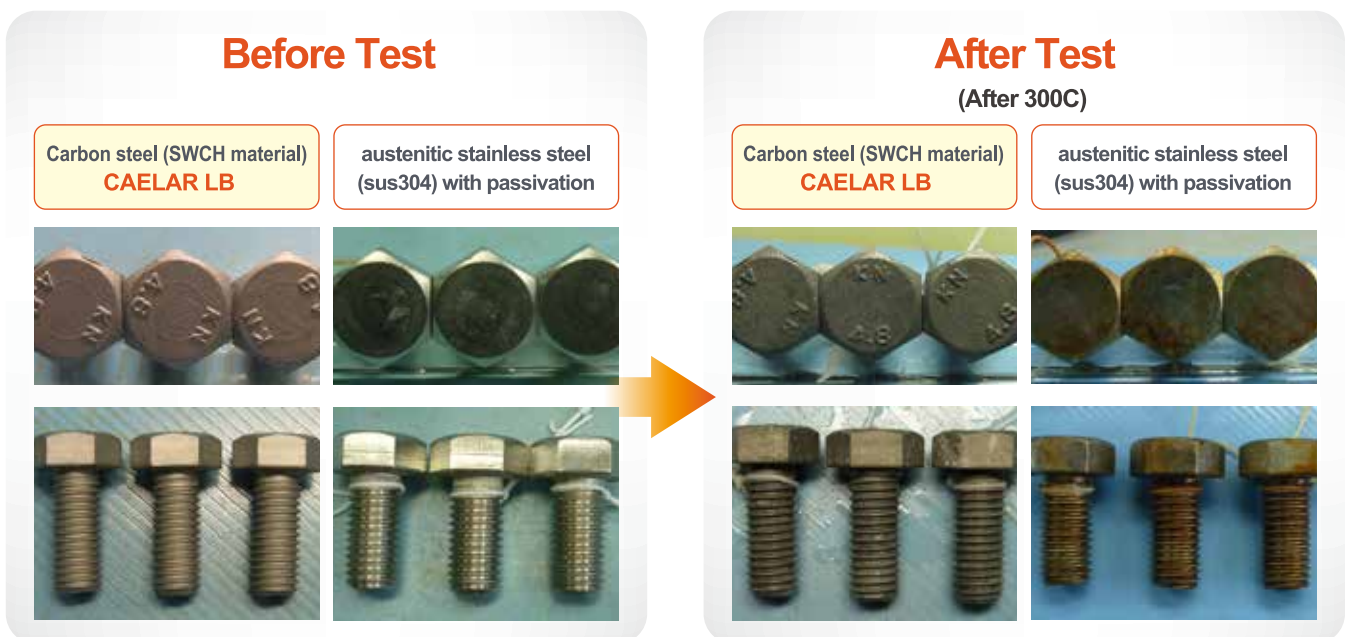
## 2. Combined cycle test

JASO M609-91 / 300 cycle finish

No red rust occurred

Test sample: Bolt M8 x 20  
Film thickness: 11µm

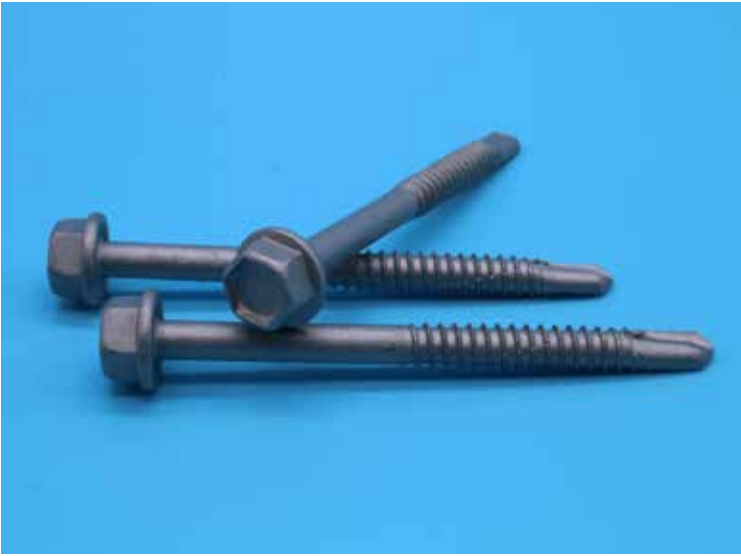
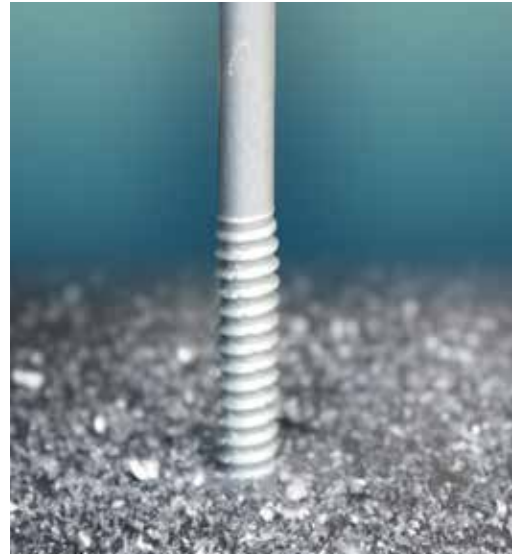
Film performance test after Drilling screw in and out of the steel plate cold commercial by one time which have 6mm thickness

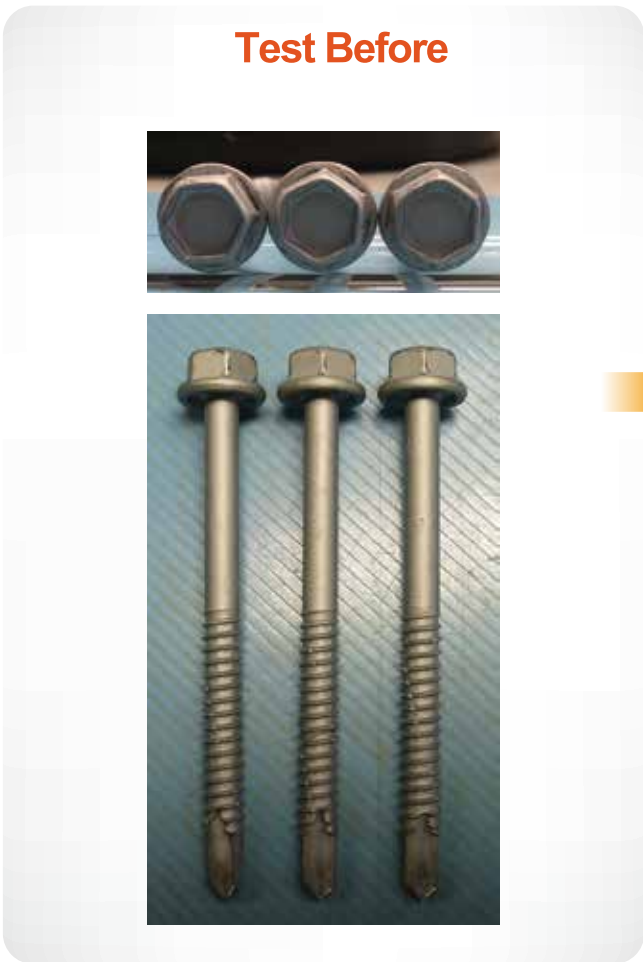
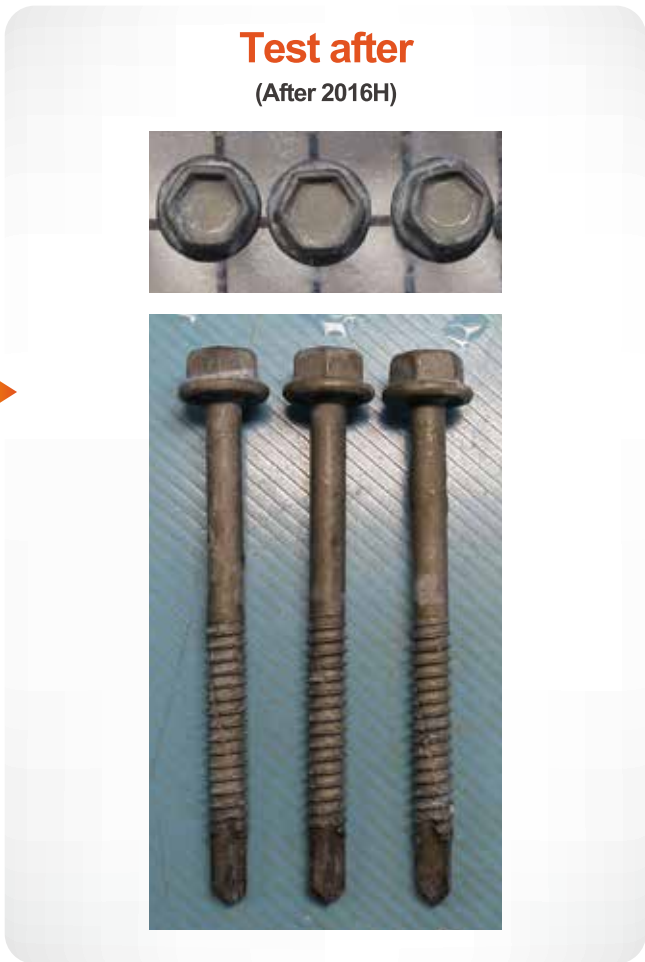
### 3. drilling test (salt spray test)

spcc 6mm drilling in and out of the iron plate

JIS Z 2371 / 2016H finish **No red rust occurred**

Test sample: hex self-drilling screw M6×70  
Material: SUS410 + CAELAR LB  
Film thickness: 14.6 μm

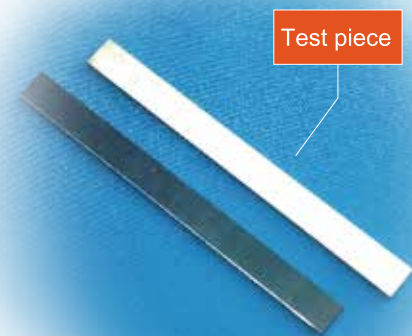
Description	Sample A	Sample B	Sample C
Distance until Broken (mm)	85.0	83.2	42.3
	85.0	85.0	36.3
	85.0	84.1	40.2
	85.0	81.2	36.2
	85.0	85.0	35.3
Average distance until broken (mm)	85.0	83.7	38.1

left:substrate right:test piece with plating

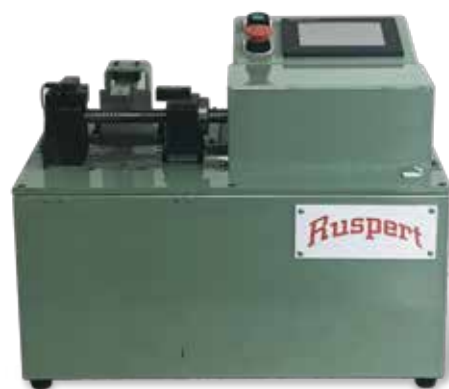
Test piece

Hydrogen Embrittlement Rate (%) =  $(L_0 - L) 100 / L_0$   
 $L_0$ : Bending until snapping distance using the piece (substrate) without hydrogen embrittlement issue(mm)  
 $L$ : Bending until snapping distance using the test piece treated by pickling process with hydrogen embrittlement issue

Sample A : Substrate (without treatment)  
 Sample B : CAELAR LB  
 Sample C : Traditional Zinc Electroplating (No baking treatment)

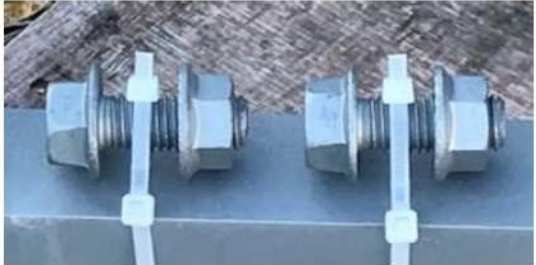
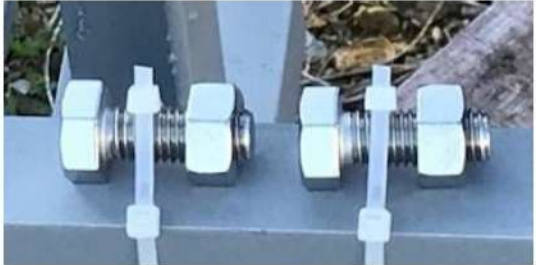
Steel with CAELAR LB	SUS 304
<b>At start of test</b>

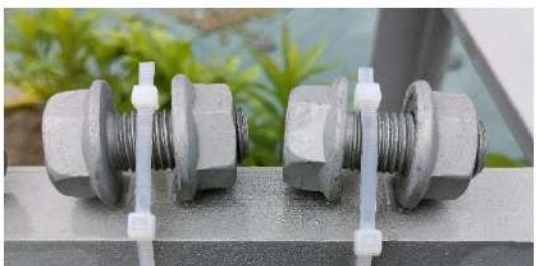
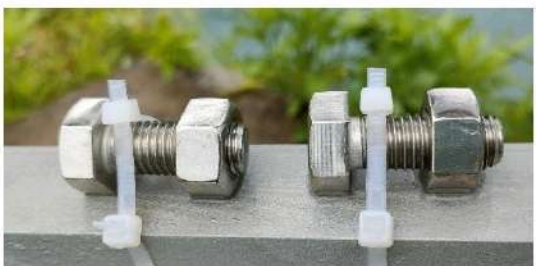
<b>Six months elapsed</b>

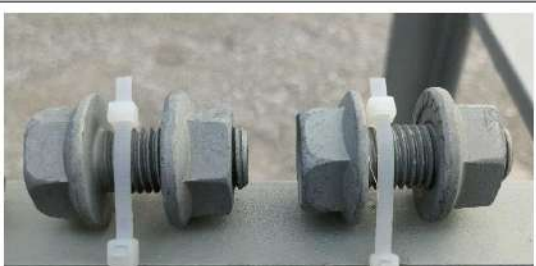
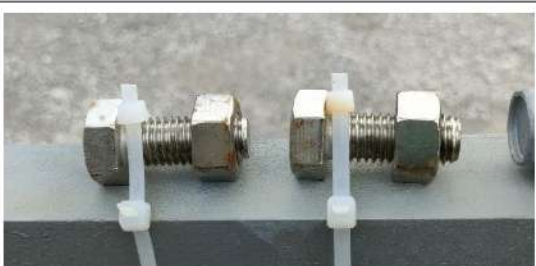
<b>1 year elapsed</b>

Rusting of SUS304 is confirmed after 1 year.

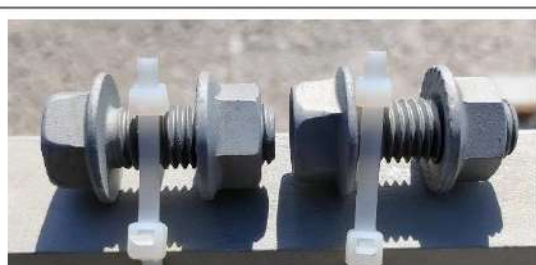
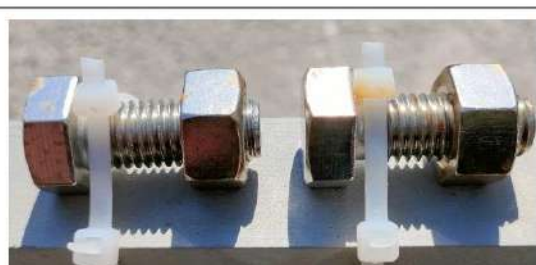
<b>1 year and 3 months (as of the end of March, the latest)</b>

Kaera LB maintains its aesthetic appearance after 1 year and 3 months
